TEST REPORT

# Tier8 High Security Junction Box (HSJB)

Evaluation of the HSJB in accordance with the requirements of Tier 8 Testing Methodology and Compliance Document V1.1 and selected clauses of BS EN 50131-3

Report number: P130175

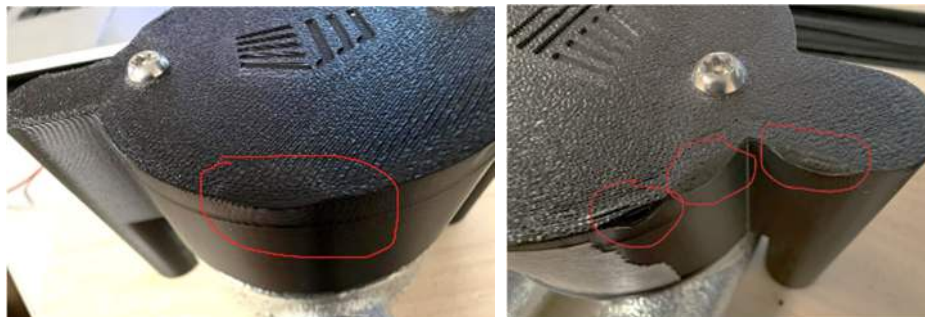
There were no visible signs of cracking or structural failure of the plastic housing after the impacts. Close visual inspection revealed only superficial damage which amounted to slight indentations to the HSJB housing coincident with the points of impact, Figure 5.

Figure 5 Superficial damage slight indentations to the HSJB housing

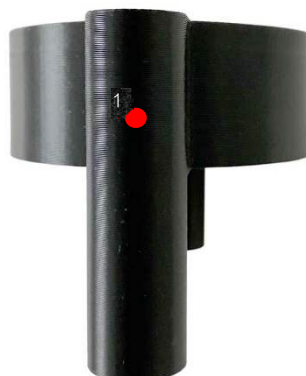
Following two impacts at point 1 shown in Figure 8, damage occurred to the push-button switch located inside the HSJB housing on the opposite side to the impact point. The cap of the push-button switch broke off, which resulted in the generation of a tamper signal, Figure 9.

Figure 8 Impacts to surface B

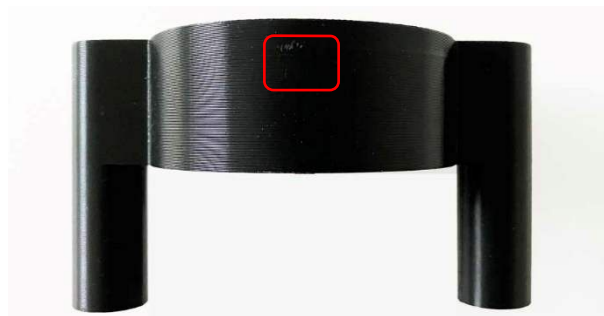
Impacts at points 2 and 3 had no notable effects. There were no visible signs of cracking or structural failure of the plastic housing after the impacts. Close visual inspection revealed only superficial damage which amounted to slight scratching to the HSJB housing coincident with the point of impact at point 1, Figure 11.

Figure 11 Superficial damage - slight scratch to the HSJB housing

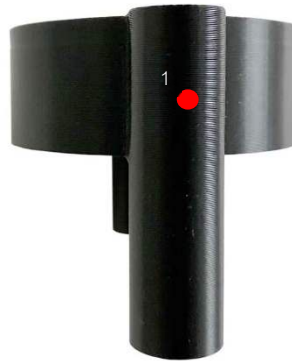
An impact at point 1 shown in Figure 12, created similar damage to the push-button switch located inside the HSJB housing on the opposite side to the impact point as described in the test for impacts to surface B. Figure 9 refers. The cap of the push-button switch broke off, which resulted in the generation of a tamper signal.

There were no visible signs of cracking or structural failure of the plastic housing after the impact. Close visual inspection revealed only superficial damage which amounted to slight indentations to the HSJB housing coincident with the points of impact.

Figure 12 Impacts to surface D
